RECHARGE FEASIBILITY STUDY USBR POND SOUTH OF CORNING CANAL

TEHAMA COUNTY FCWCD
AND CORNING SUB-BASIN GSA

**Luhdorff &
Scalmanini**
Consulting Engineers

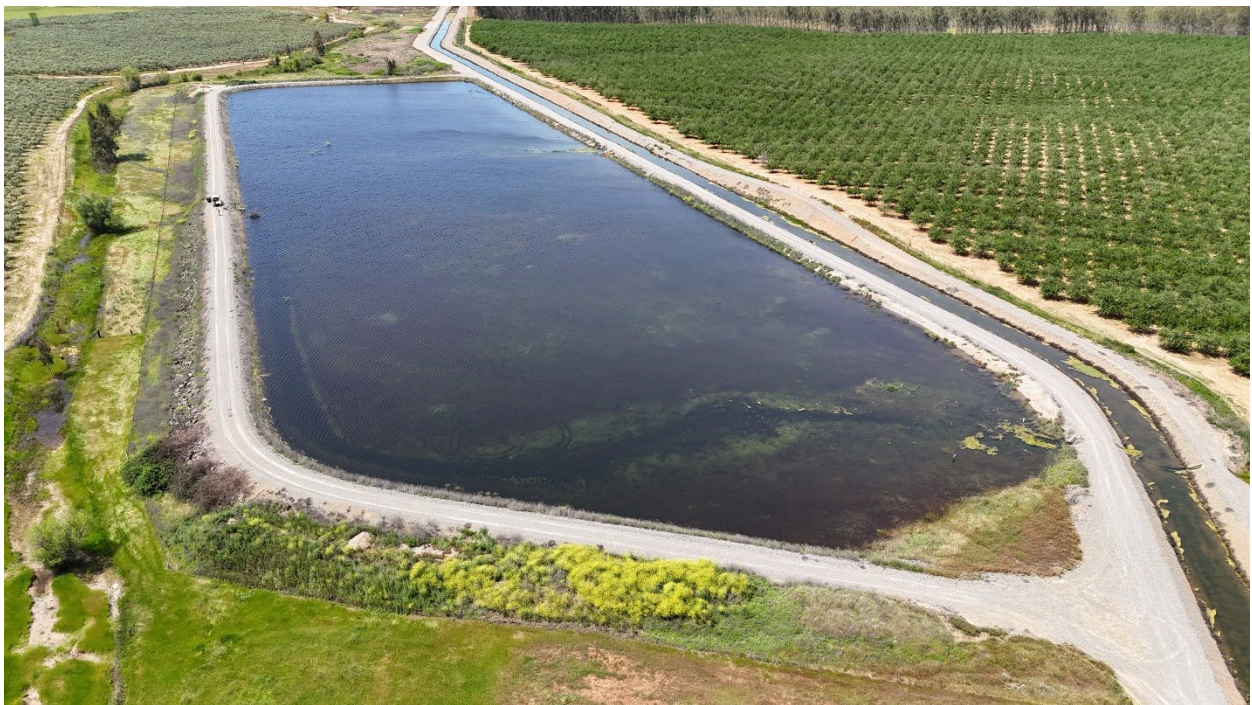
The USBR pond is located north of Liberal Avenue, near the Corning Canal, in the Corning Subbasin. The pond is approximately 10 acres. The outlet from the pond was sealed to ensure accurate measurement of evaporation and seepage. Water was added to the pond from the Corning Canal through an inlet. A total of 45 acre-feet was added to the pond to allow for a depth of water between four and five feet. A small dock extended out into the pond and was utilized to suspend monitoring equipment.

Figure 2-1 USBR Pond Aerial View

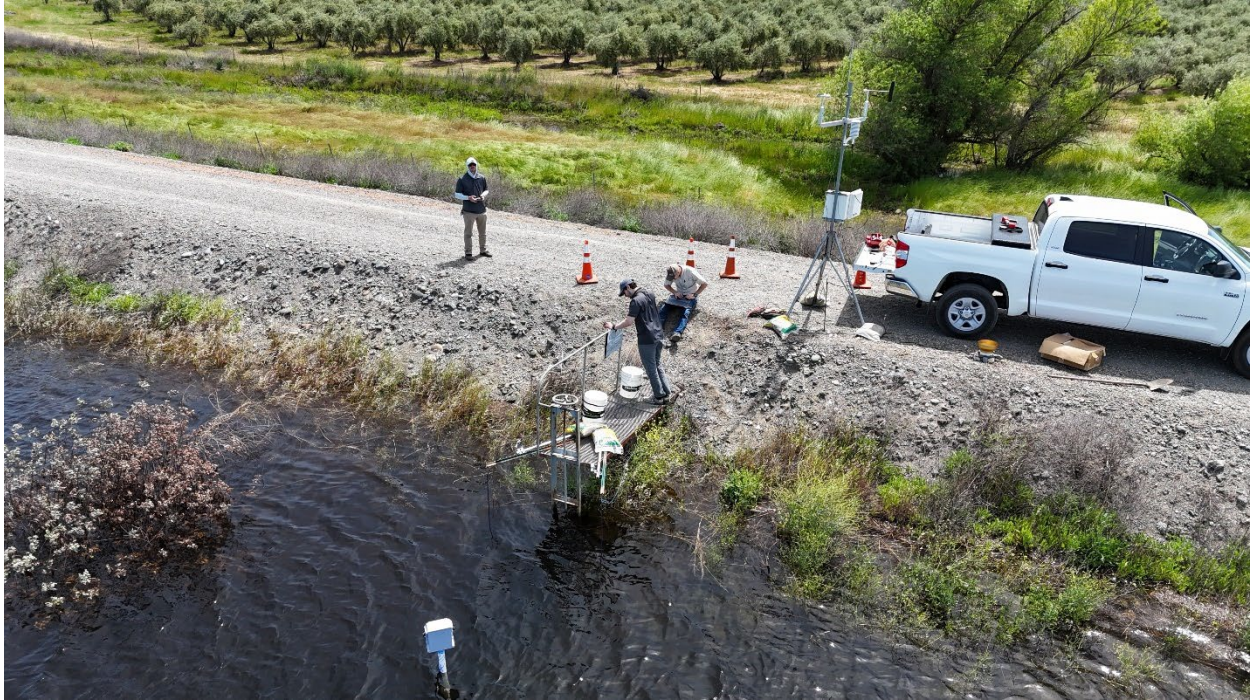
The transducers were hung from posts extended horizontally over the surface on the southeast side of the pond. A catwalk that extended out into the pond over an outlet to a neighboring creek was used to attach the posts that suspended the transducers. Two transducers were utilized to provide redundancy in data collection.

The MET station was also deployed on the southeast side of the pond in the vicinity of the transducers as depicted in Figure 2-2. It was set up on the road which runs around the perimeter levee which forms the pond, adjacent to the catwalk from which the transducers were suspended.

Figure 2-2 Monitoring Equipment Setup

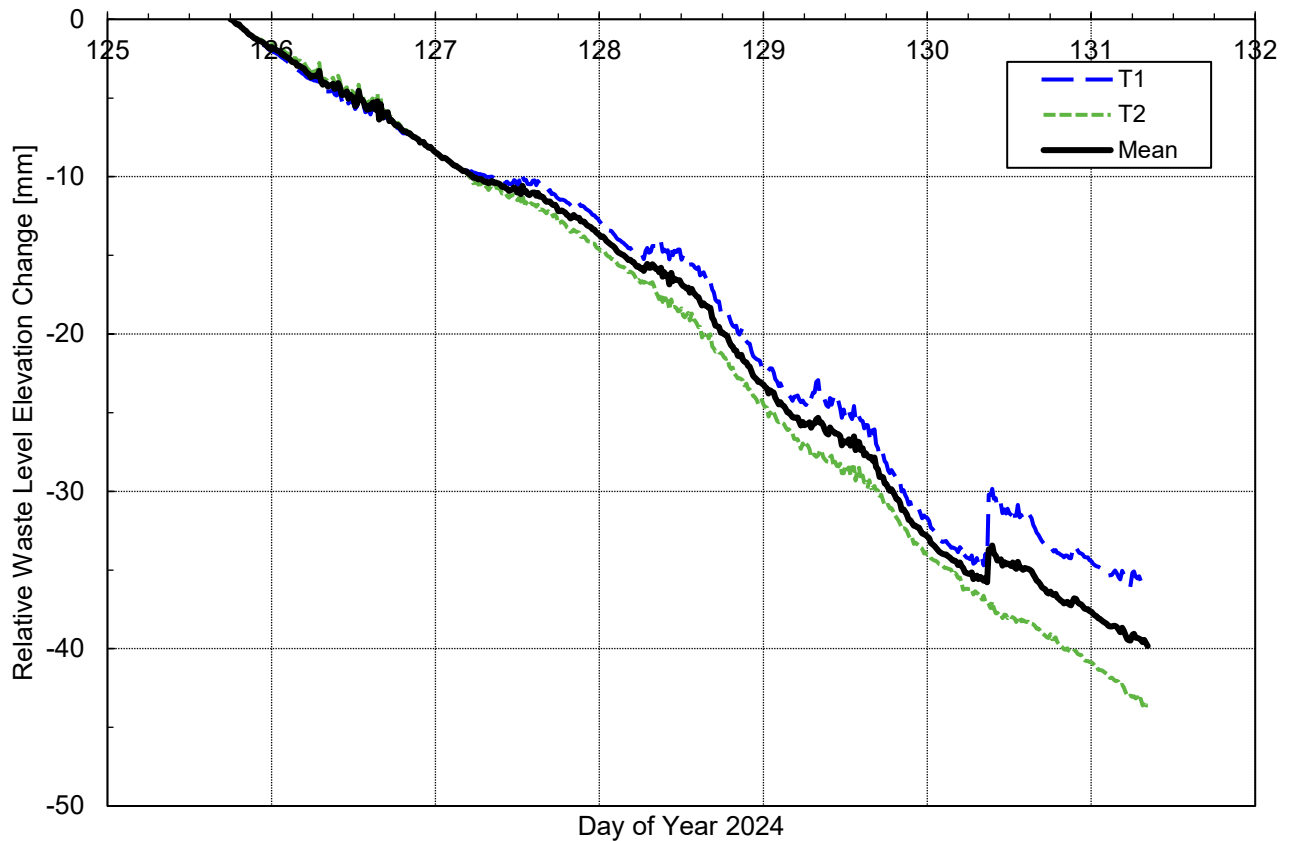
Figure 2-3 shows the data collected from both transducers (T1 and T2) and the calculated mean from both datasets. Both datasets were aggregated on 15-minute intervals starting from May 4th 2024 through May 10th 2024. A mean cumulative relative change of 39.8 mm was observed over the period from May 4th 2024 to May 10th 2024, as shown in Figure 2-3.

As seen in Figure 2-3, T1 experienced interference with water level readings as evidenced by several sharp changes recorded in water levels. This interference can be caused by the transducer being caught in vegetation within the pond. Due to this measured interference, water levels from T2 were utilized for percolation rate calculations. The cumulative change in water level in T2 was 43.6 mm.

Figure 2-3 Relative Change in Water Level Elevation

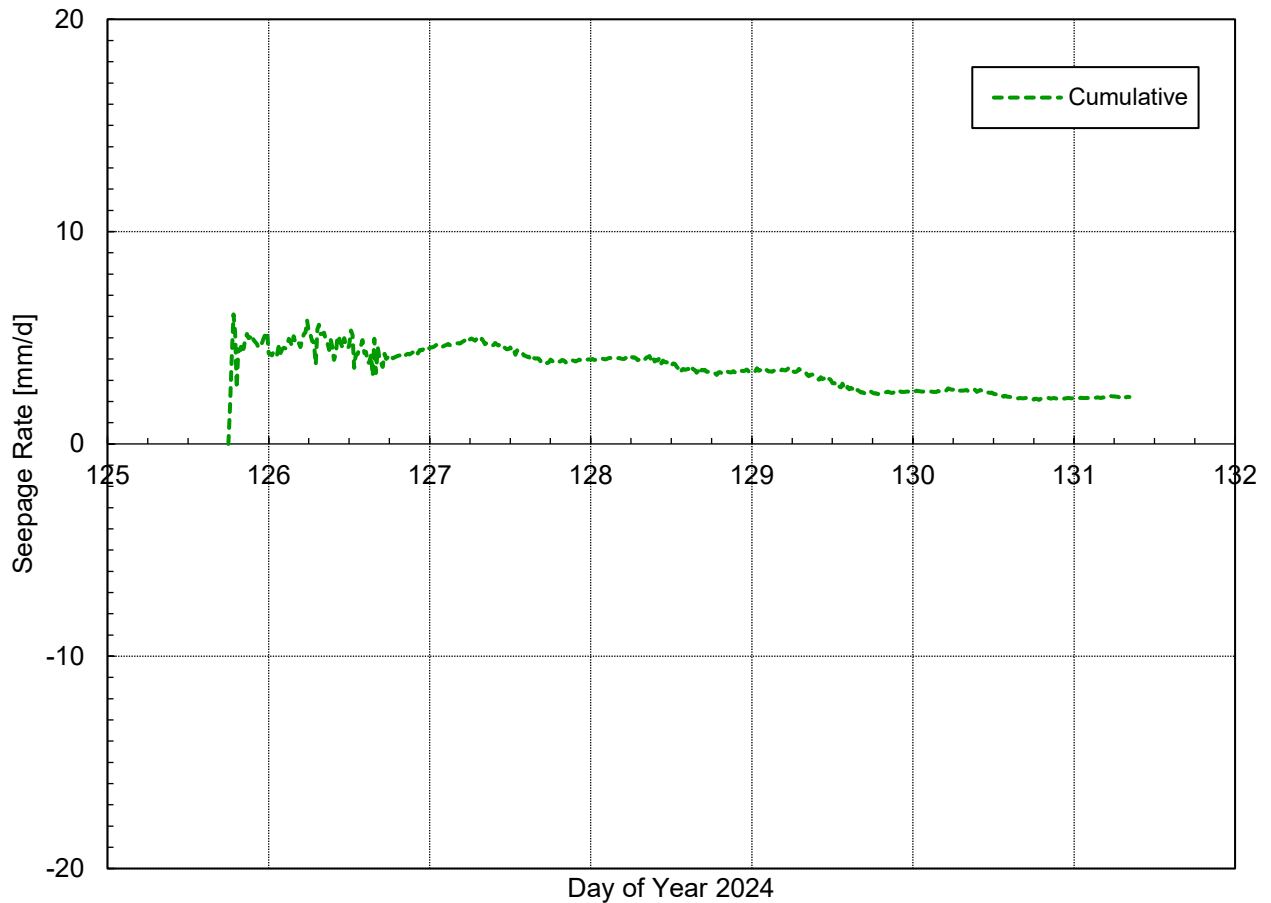
To calculate the percolation rates observed in the pond, a water balance method was utilized. The cumulative evaporation was subtracted from the cumulative change in water levels to determine the percolation rate. Based on the changes in water levels and cumulative evaporation, a percolation rate of 2.2 mm/d was calculated. These results are depicted in Figure 3-1.

Figure 3-1 Cumulative Percolation Rate

The percolation study was conducted over a span of six days. During this time, the percolation rate in the pond converged to 2.2 mm/d. When evaluated in the context of a recharge pond, this rate is very low. This low rate suggests that this pond is better suited as a water storage facility rather than a pond to be used for recharge.
