# MULTI BENEFIT RECHARGE PROJECT SIMPSON ROAD, CORNING

TEHAMA COUNTY FCWCD  
AND CORNING SUBBASIN GSA

**Luhdorff &  
Scalmanini**  
Consulting Engineers

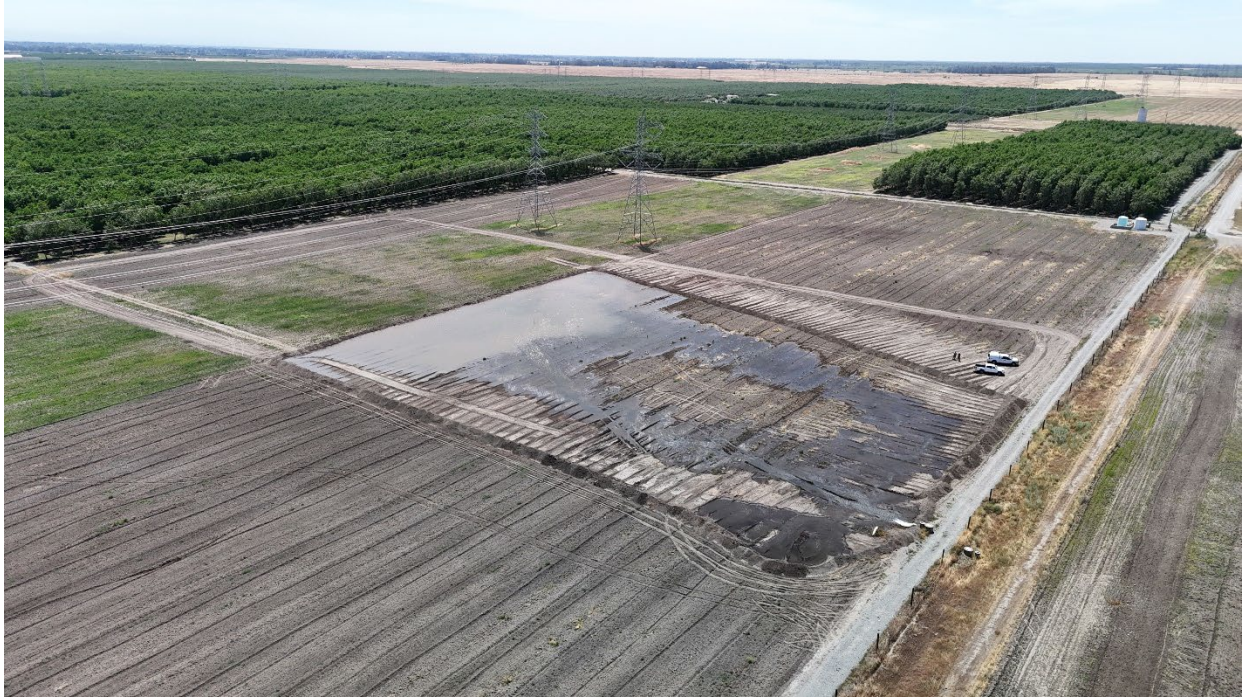
**Figure 2-1. Pilot Test #1 Basin Aerial View Looking Southeast**

The first pilot test took place on the 30-acre field on the eastern portion of the site. This field was historically planted with walnuts, but half the trees under high-voltage power lines were removed between 2013 and 2015 under an agreement with the power company. Later, between 2022 and 2024, the walnuts on the remaining portion of the field were removed as well. Since that time, the field has remained fallow, with periodic discing to control weeds. During the pilot test, the field had recently been disced and was generally free of vegetation. The field was not perfectly level during the pilot test, however the variation in elevation across the site varied only slightly. To keep water contained during the pilot test, a small basin of approximately 2.9 acres was created by a short berm (about 2 feet tall) immediately adjacent to the Corning Water District irrigation turnout (**Figure 2-1**).

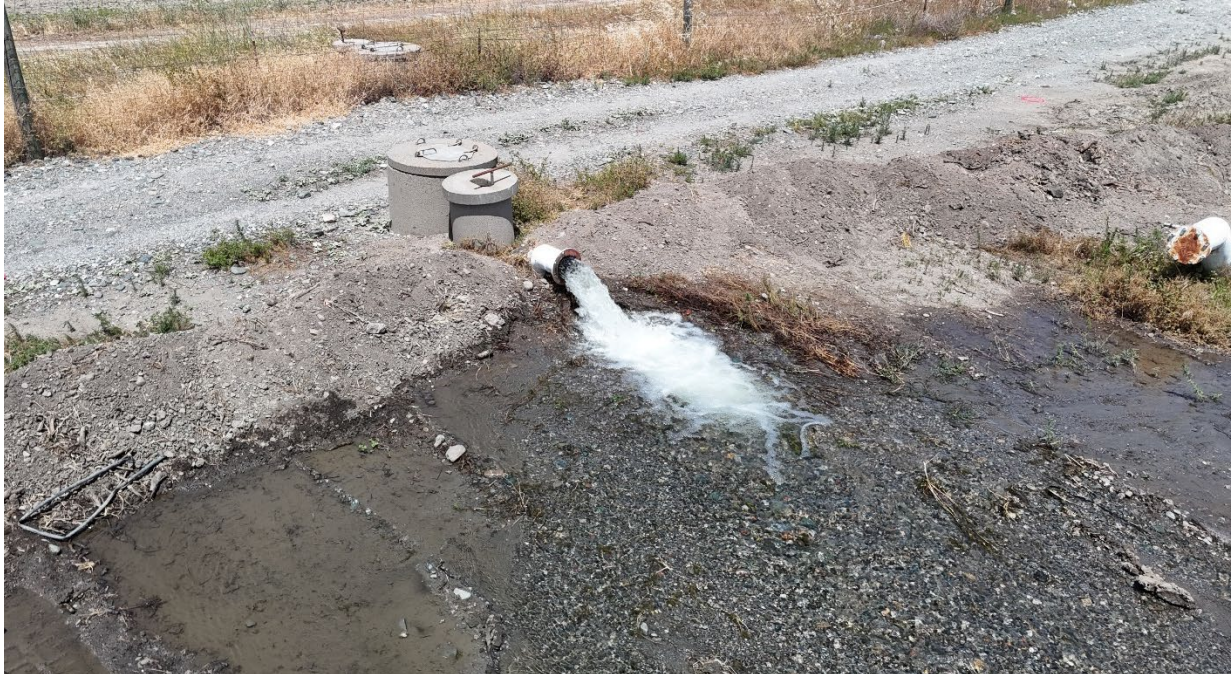
**Figure 2-2. CWD Irrigation Infrastructure and Water Flowing into the Basin**

For this pilot test, surface water obtained from CWD was directed into the basin from the existing turnout in the northwest corner of the basin. Water from the turnout was allowed to flow freely into the basin and spread (**Figure 2-2**). Due to the slight change in elevation across the site, the water tended to flow towards the eastern end of the basin. A total of 15 AF of water was applied during pilot test #1.

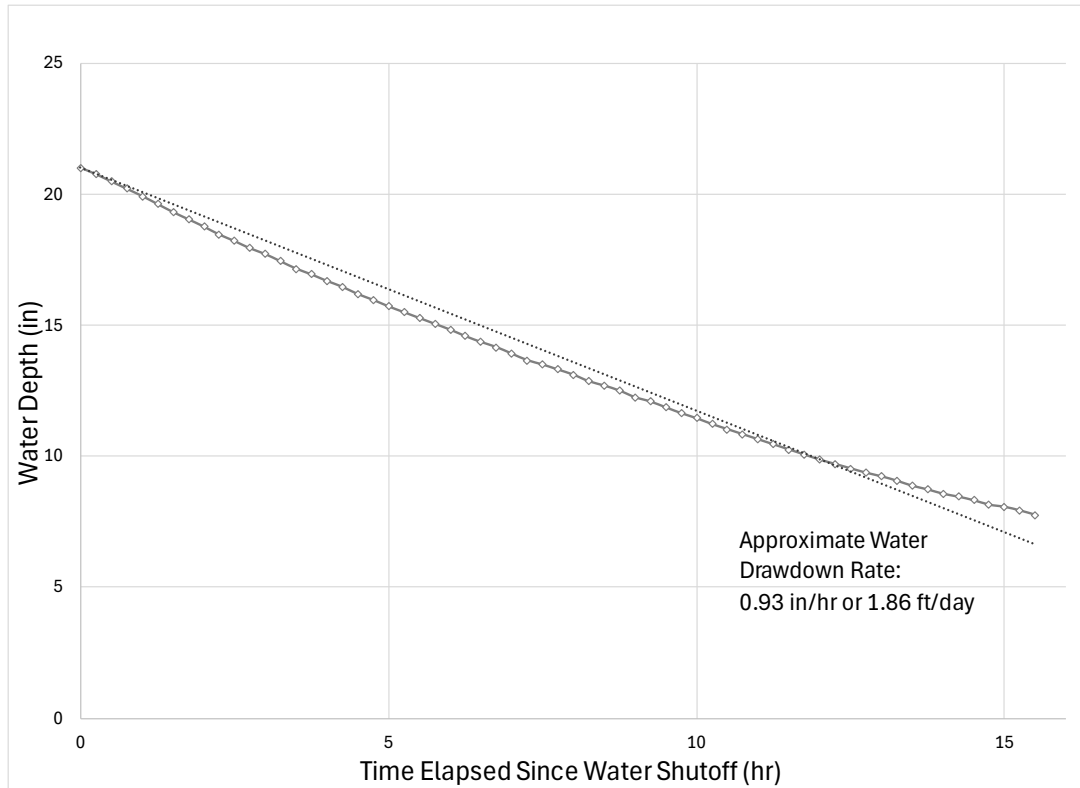
Figure 2-3a. Water Level During First Drawdown Event- May 29, 2024 to May 30, 2024

Data collected from the transducer deployed at the deepest part of the basin was analyzed during the first and second drawdown events. Depth data were collected at 15-minute intervals and plotted (**Figure 2-3a and Figure 2-3b**). A best fit line was generated to determine the approximate water infiltration rate in both inches per hour and feet per day for both drawdown events. During the first drawdown under dry conditions, the drawdown rate was calculated at 0.93 in/hr or 1.86 ft/day. For the second drawdown under saturated conditions, the drawdown rate was calculated at 0.77 in/hr or 1.54 ft/day.

As described in Section 2.3.1, the actual infiltration rate of water into the subsurface is determined by the measured drawdown rate at the transducer, plus the precipitation rate (in this case zero), minus the evaporation rate, yielding the final infiltration rate. The final infiltration rate for the first event, under dry conditions, was 0.92 in/hr or 1.85 ft/day. The infiltration rate for the second event, under saturated conditions, was 0.77 in/hr or 1.53 ft/day. The calculations for each of the two drawdown events are summarized in **Table 2-4** below. Overall, the rate of evaporation is minimal when compared to the overall drawdown rate, resulting in total infiltration being only slightly lower than the total drawdown rate, suggesting a high recharge potential at this location.

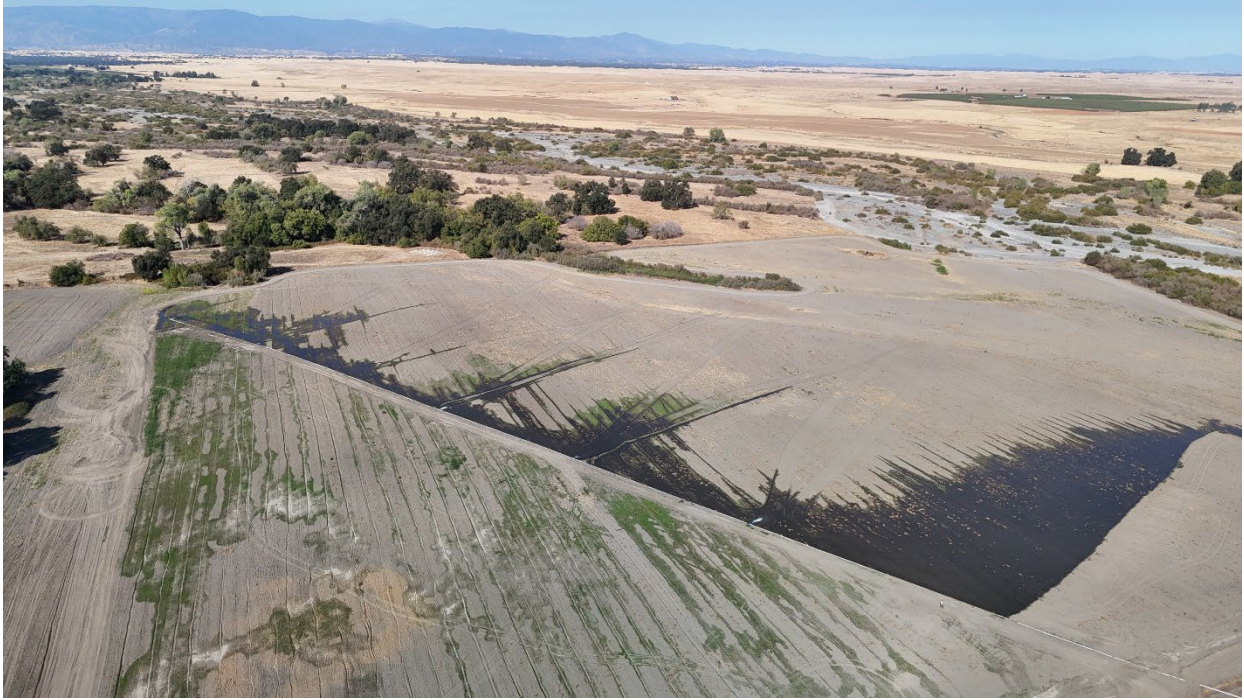
**Figure 3-1. Pilot Test #2 Basin Aerial View Looking Northwest**

The field for the second pilot test was approximately 42 acres and was located immediately to the west of the field used in pilot test #1. Based on a review of historical satellite imagery of the area, prior to 2015, this was utilized for grazing, with some cross fencing and scattered trees on the property. Since 2015, the field has remained fallow or has been planted in short-duration annual crops. At the start of the pilot test, the field had recently been disced and was largely free of vegetation. Like the field in pilot test #1, this site was uneven, sloping gently to the north toward Thames Creek. This test site also had a basin created by a short berm, similar to pilot test #1. Furthermore, additional berms were created within the basin to address the change in elevation and help distribute water across the site. (**Figure 3-1**).

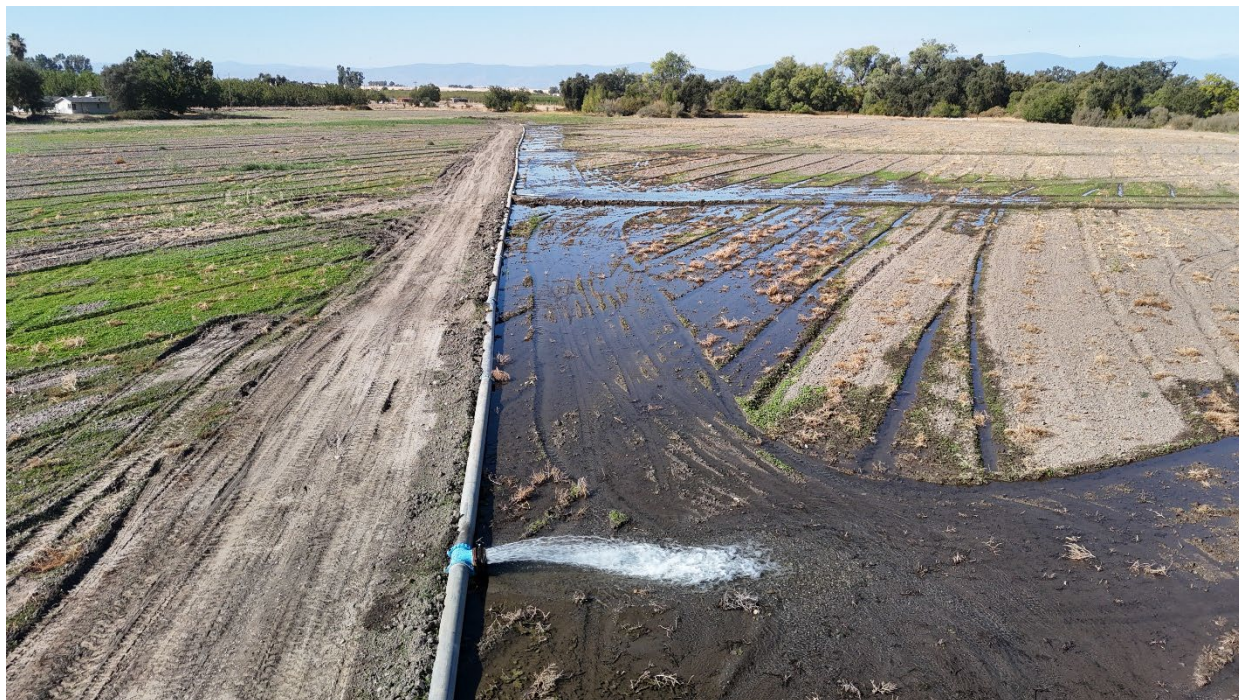
**Figure 3-2. Pilot Test #2 Basin Showing Pipeline and Outlets**

Water delivery followed a similar method as in the first test, using the same CWD irrigation turnout. A temporary pipeline with multiple outlet points directed water from the irrigation turnout to the site and distributed it across the basin (**Figure 3-2**). During this pilot test, 271 acre-feet of surface water procured from CWD was applied to the site. The cost of the water applied during the pilot test was \$21,737.60. The funding to purchase the water from CWD was provided by TNC.

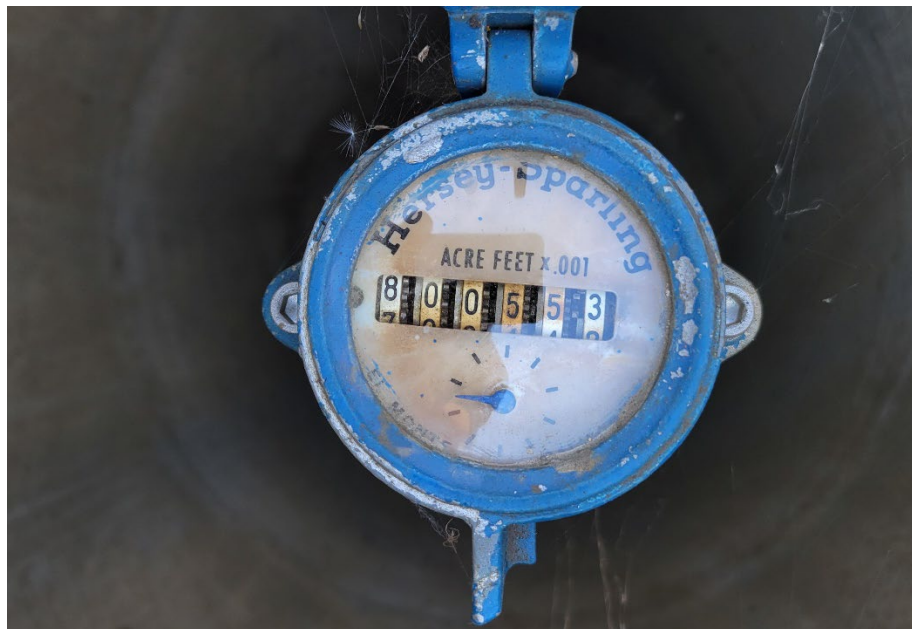
Figure 3-3. Corning Water District Meter

During this test, the water within the basin was to be kept shallow to provide ideal habitat for selected bird species. Due to the shallow water, measuring water level with transducers was not practical. Meter readings were taken at the beginning and end of the test to determine the total volume of water applied, measured in acre-feet (see **Figure 3-3**). Water was applied continuously to the site from September 13, 2024 through November 13, 2024. However, there were a few instances of the water flow rate into the basin being increased, decreased, or fully stopped to allow for maintenance of the berm surrounding the basin.
