FEASIBILITY STUDY | JUNE 2025

THOMES AND ELDER CREEK DIVERSIONS FOR DIRECT OR IN-LIEU GROUNDWATER RECHARGE RED BLUFF SUBBASIN

TEHAMA COUNTY FCWCD

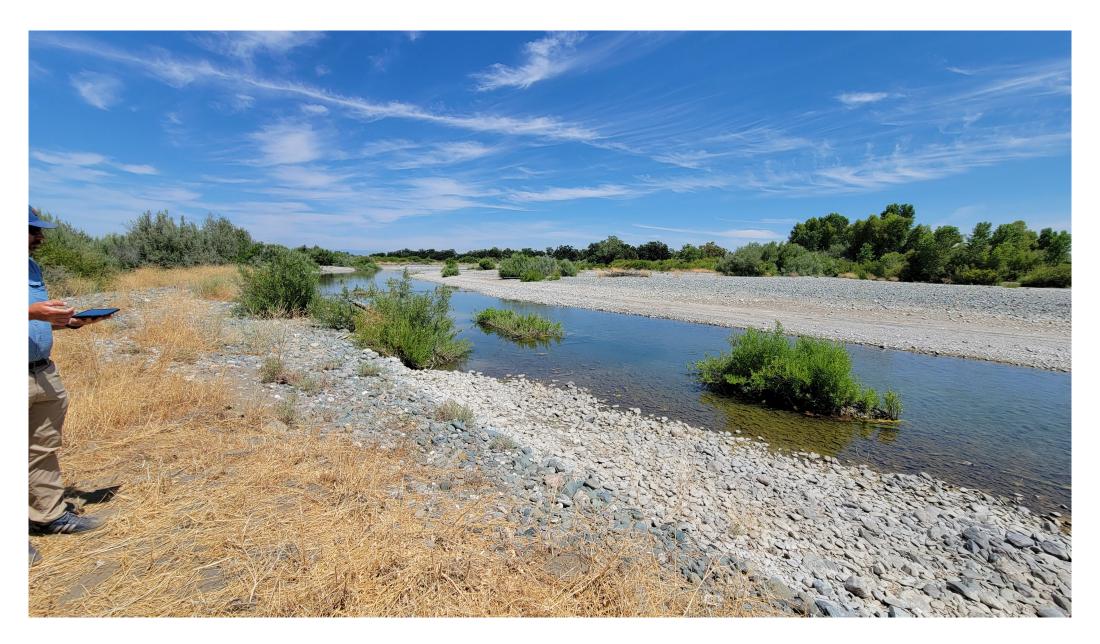
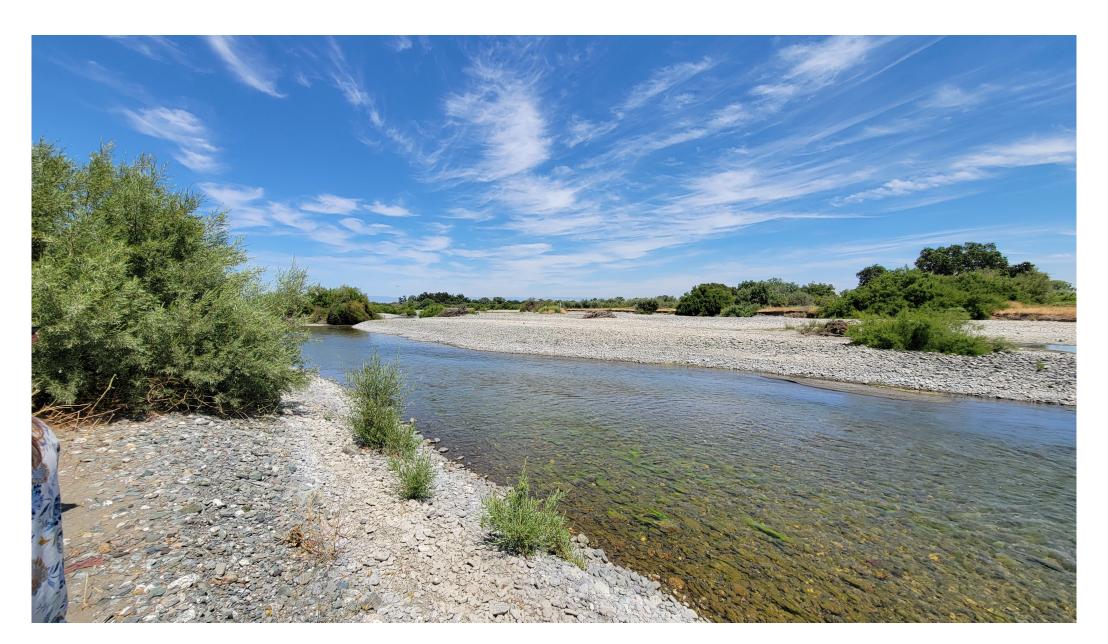
North Thomes Creek- Potential Diversion Point

As this site is directly adjacent to Thomes Creek, pump and piping requirements to divert water during high flow events will be minimized. A total of about 2,000 feet of pipe would be sufficient to divert water from the creek to the highest portion of the recharge area.

As stated in the previous section, temporary pumps and piping will be used for pilot testing on the site. However, based on information gathered during site visits, some minimal construction on this site prior to pilot testing would also be beneficial. Minor leveling and construction of berms on the site would maximize the ability to apply and spread water on the site and prevent surface flow back towards Thomes Creek. If pilot testing is successful on the site, more permanent structures for diverting and directing flow from Thomes Creek will be investigated.

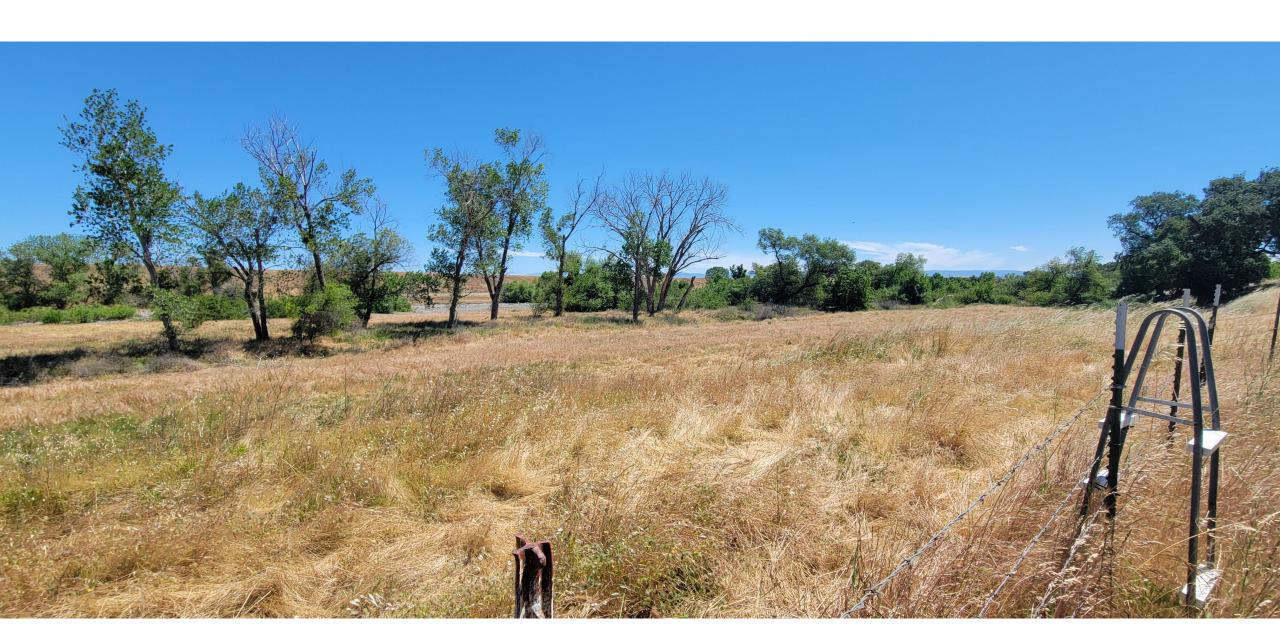
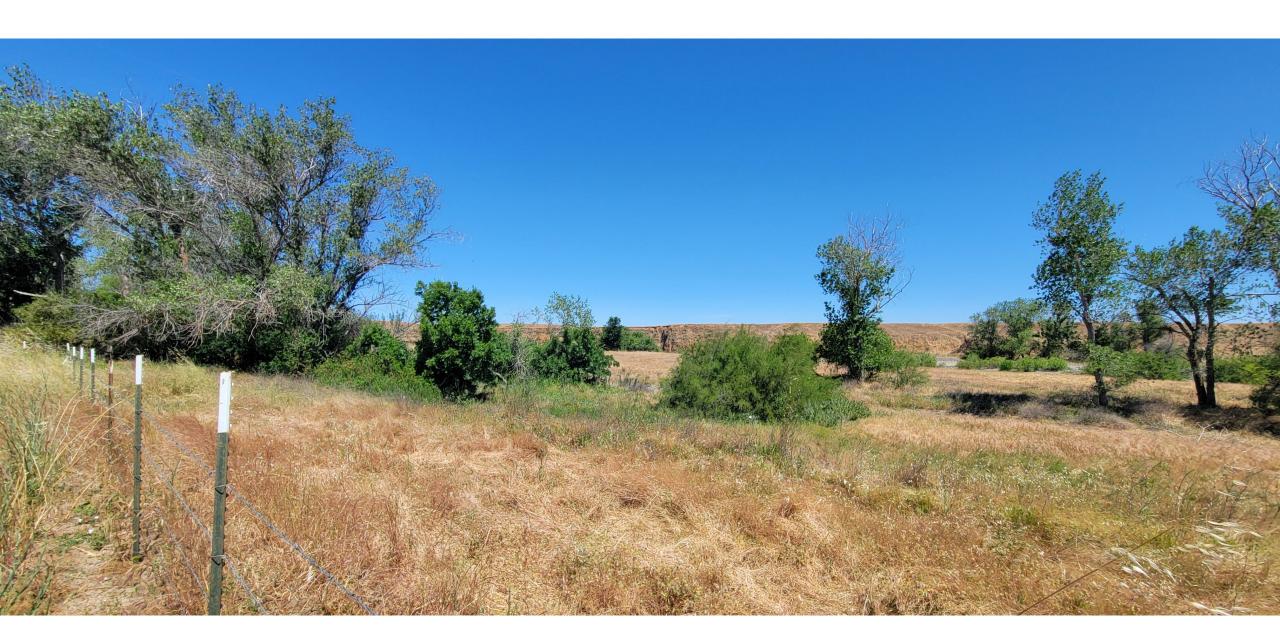
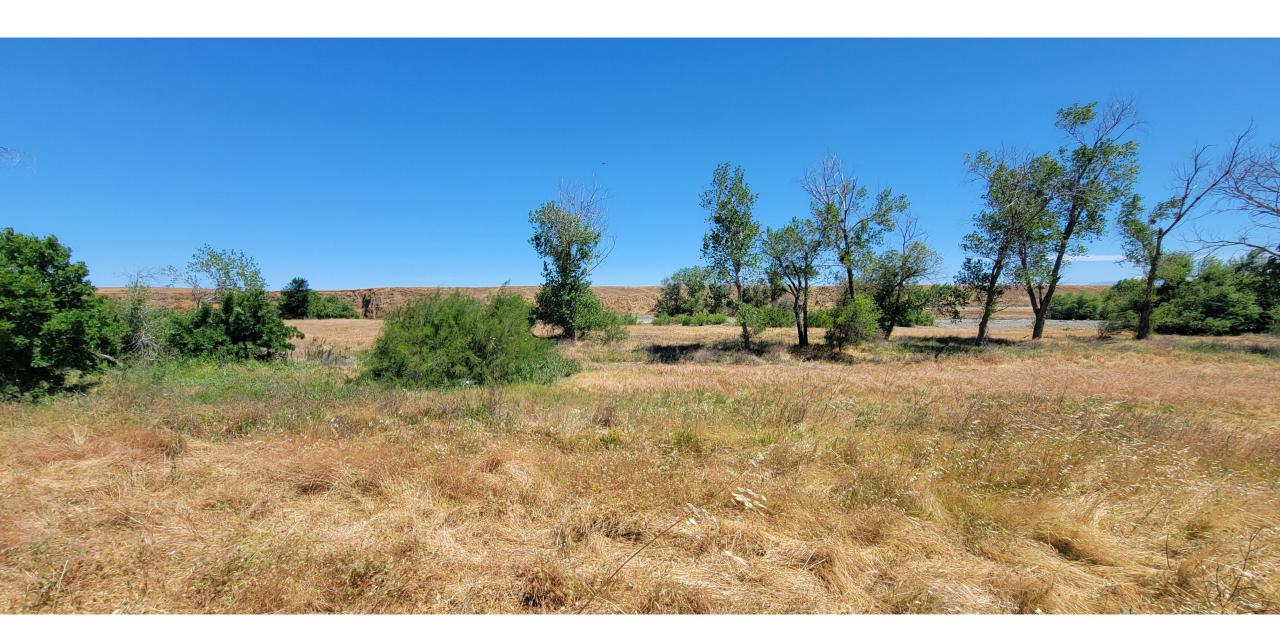
Rancho Tehama- Recharge Area

Temporary pumps and piping will be used on the Rancho Tehama site to direct water to the recharge area. Based information gathered during site visits, some minor leveling and construction of berms may be beneficial. During the pilot testing phase, the site will be observed to determine if any further modifications to the site are necessary to encourage spreading and infiltration of applied water. If pilot testing is successful on the site, more permanent structures for diverting and directing flow from Elder Creek will be investigated.

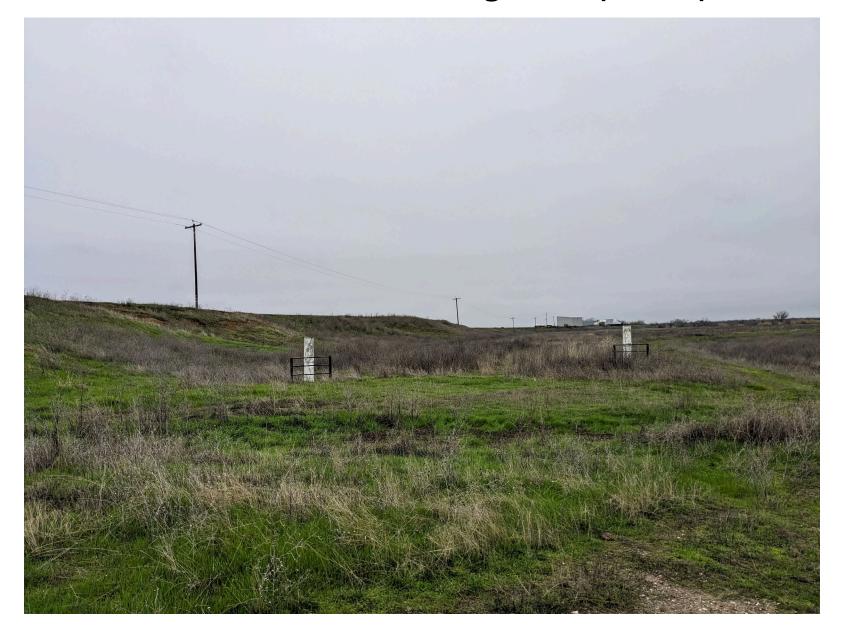
Marenco Ranch- Recharge Area (winter)

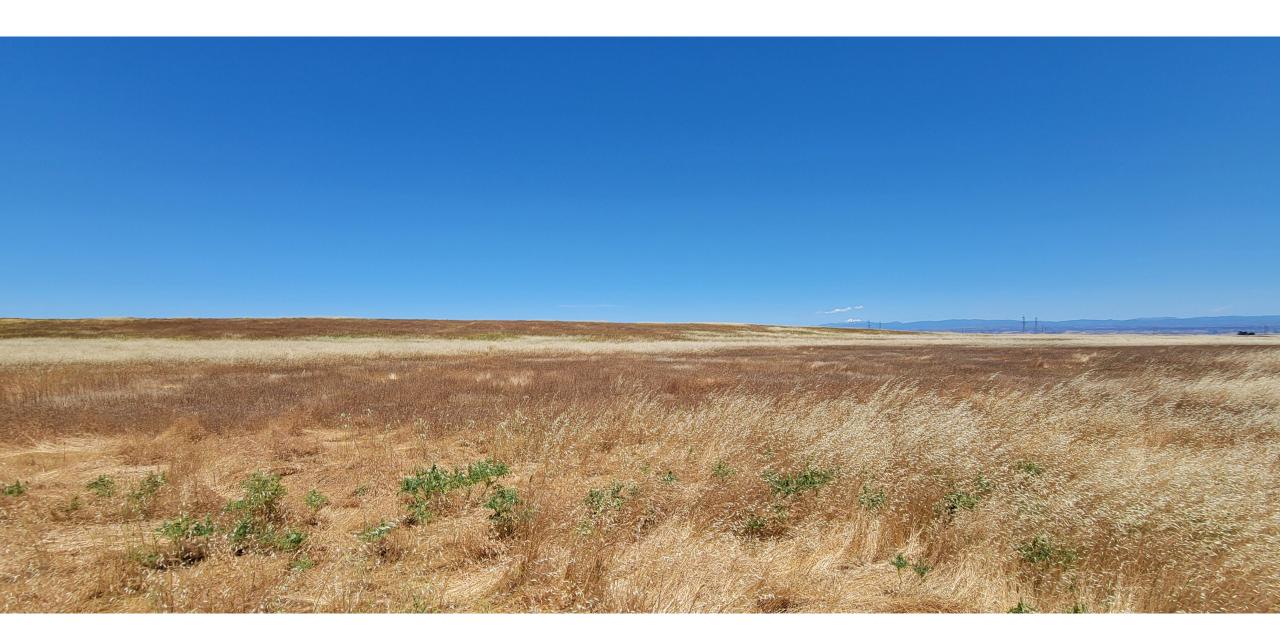
Marenco Ranch-Typical Vegetation (summer)

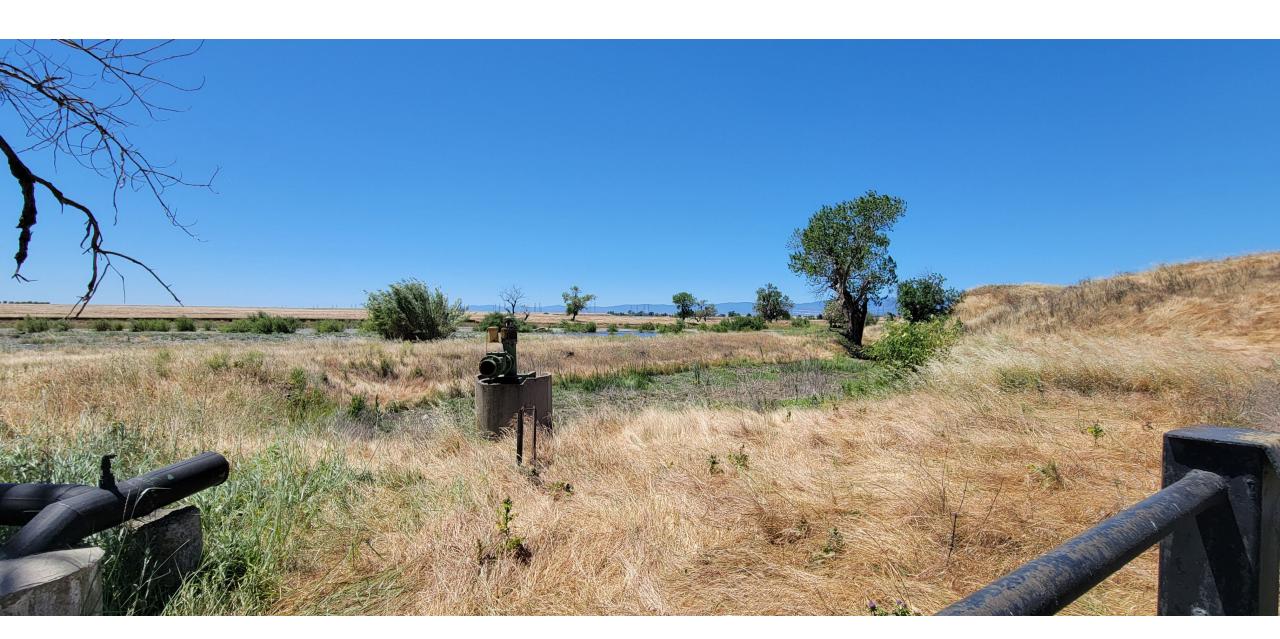
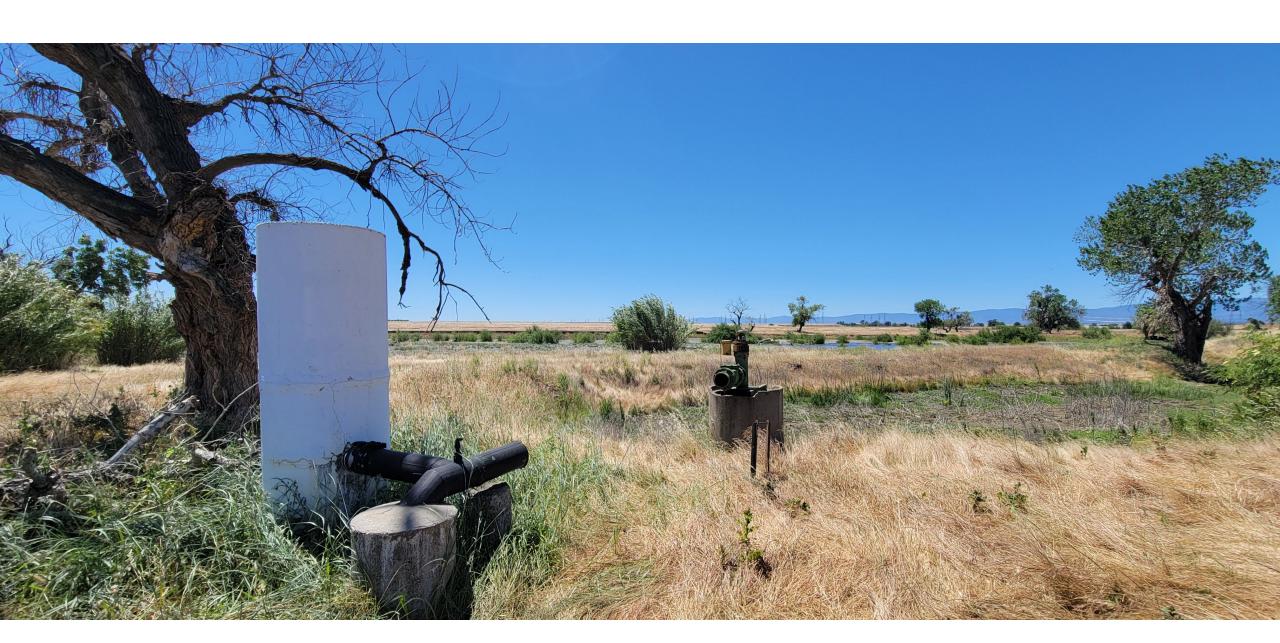
Marenco Ranch- Diversion Point

Temporary pumps and piping will be used on the Marenco Ranch site to direct water to the identified recharge areas. During the pilot testing phase, the site will be observed to determine if any further modifications to the site are necessary to encourage spreading and infiltration of applied water. If pilot testing is successful on the site, more permanent structures for diverting and directing flow from Elder Creek will be investigated.
