# **Technical Memo, Groundwater Dependent Ecosystems survey in Antelope, Corning, and Red Bluff subbasins of Tehama County**

Applied Ecologist, Sub-Terra Heritage Resource Investigations

Final Tech Memo. March 24, 2026

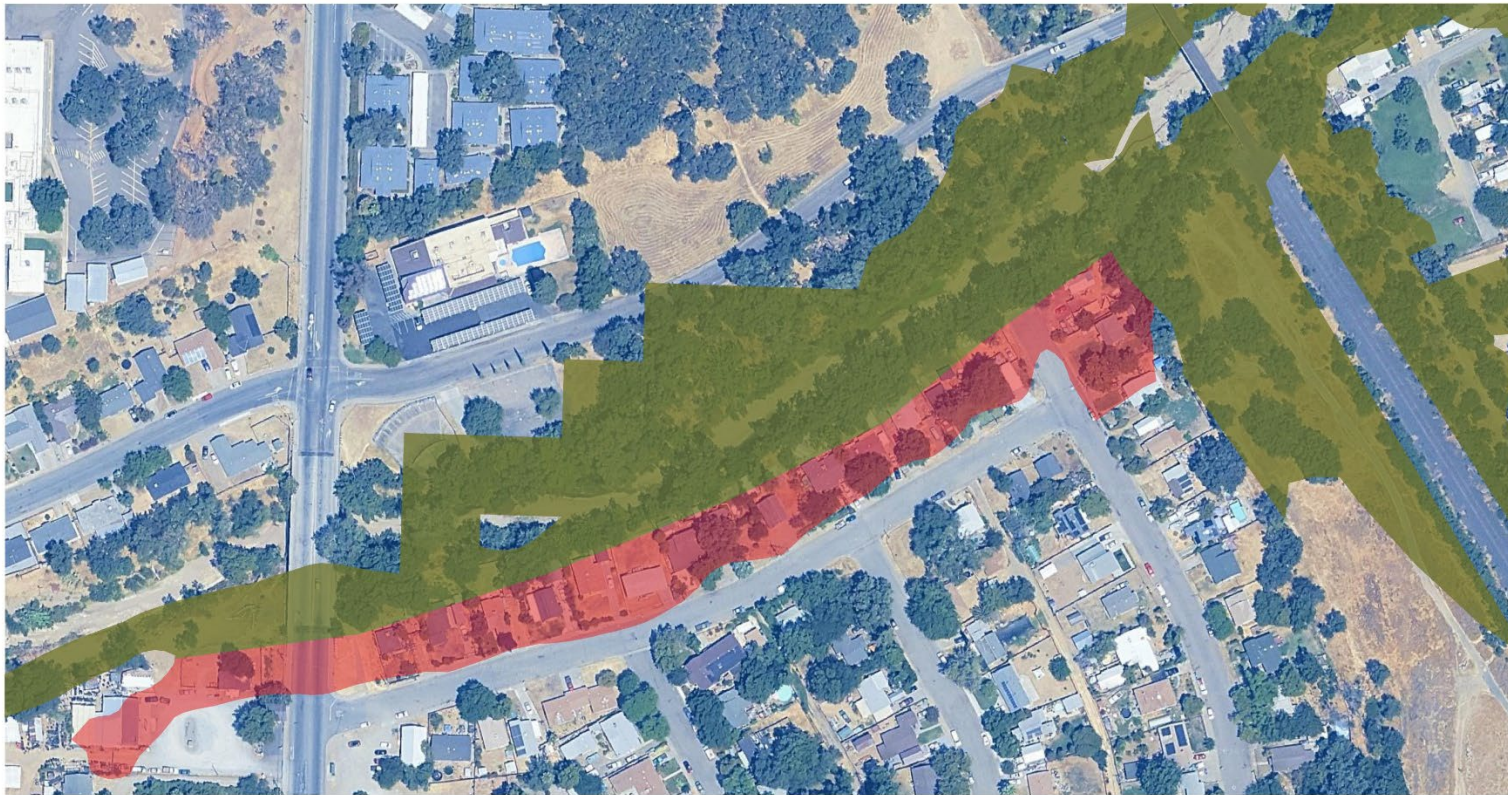
Example of iGDE from NCCAG dataset that has been modified due to changes in land use in the Red Bluff subbasin. The red area has been removed from the original polygon due to the presence of more structures than trees.

Finally, we adjusted the extent of some polygons if they included areas that were not consistent with the majority of the polygon (see Appendix 1 for example). For instance, some large polygons had narrow slivers that followed roads, with no identifying GDE characteristics within the slivers. These slivers were removed to create a more homogenous polygon. In addition, some large polygons had houses or other improvements or had portions that were currently in fruit tree production and these features were excluded from the polygon, keeping the remaining, more natural, vegetation as the GDE.

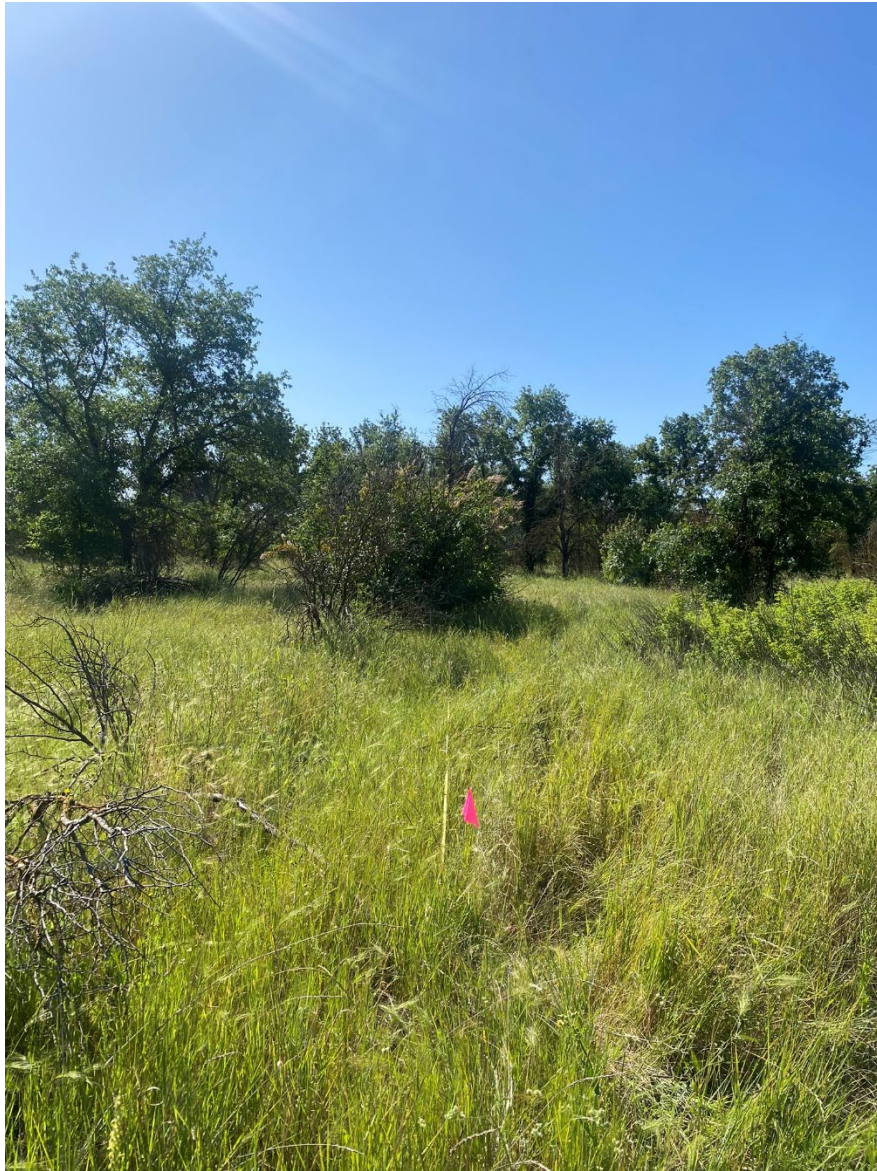
*Figure A2.1: Valley Oak woodland transect at Butler Slough, Antelope subbasin (photo taken 5/24/2024)*

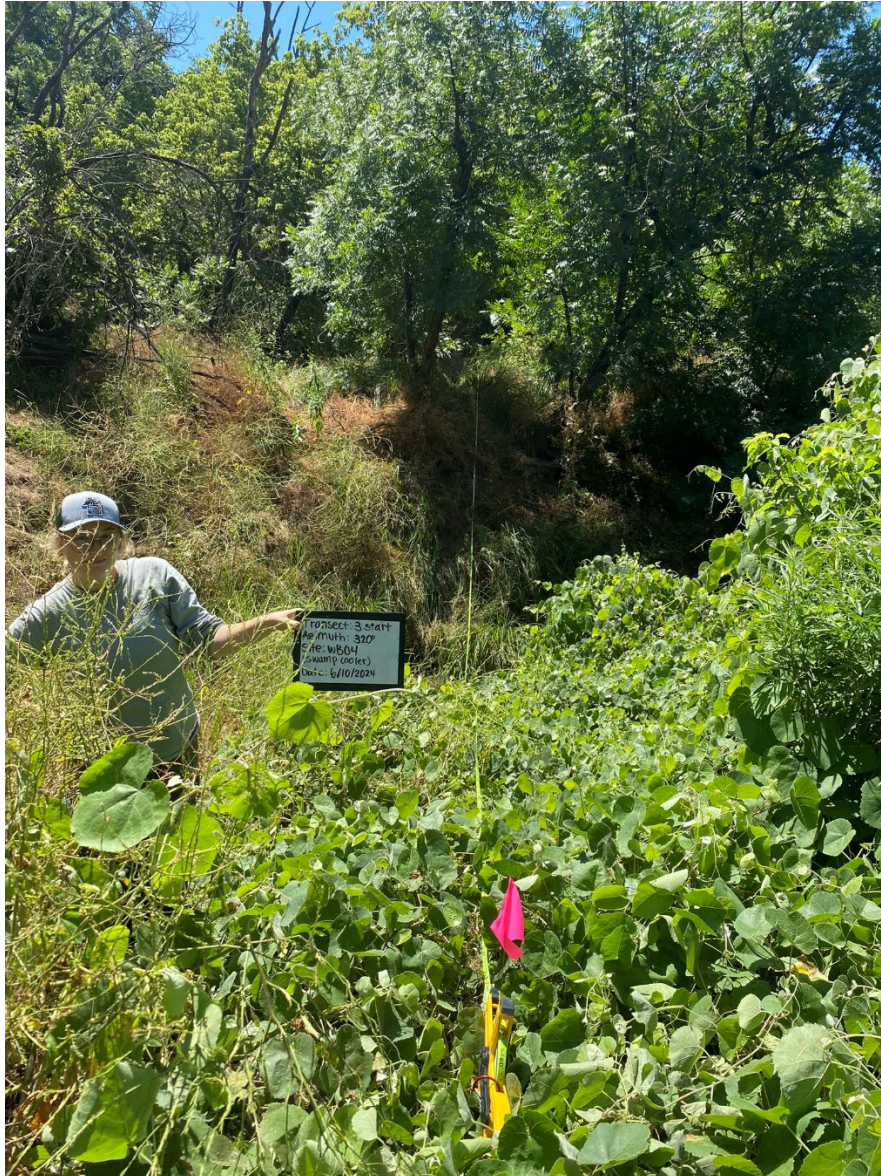
Figure 8: Box elder transect in Woodson Bridge Preserve (State Parks), Corning subbasin. Photo taken 6/10/2024

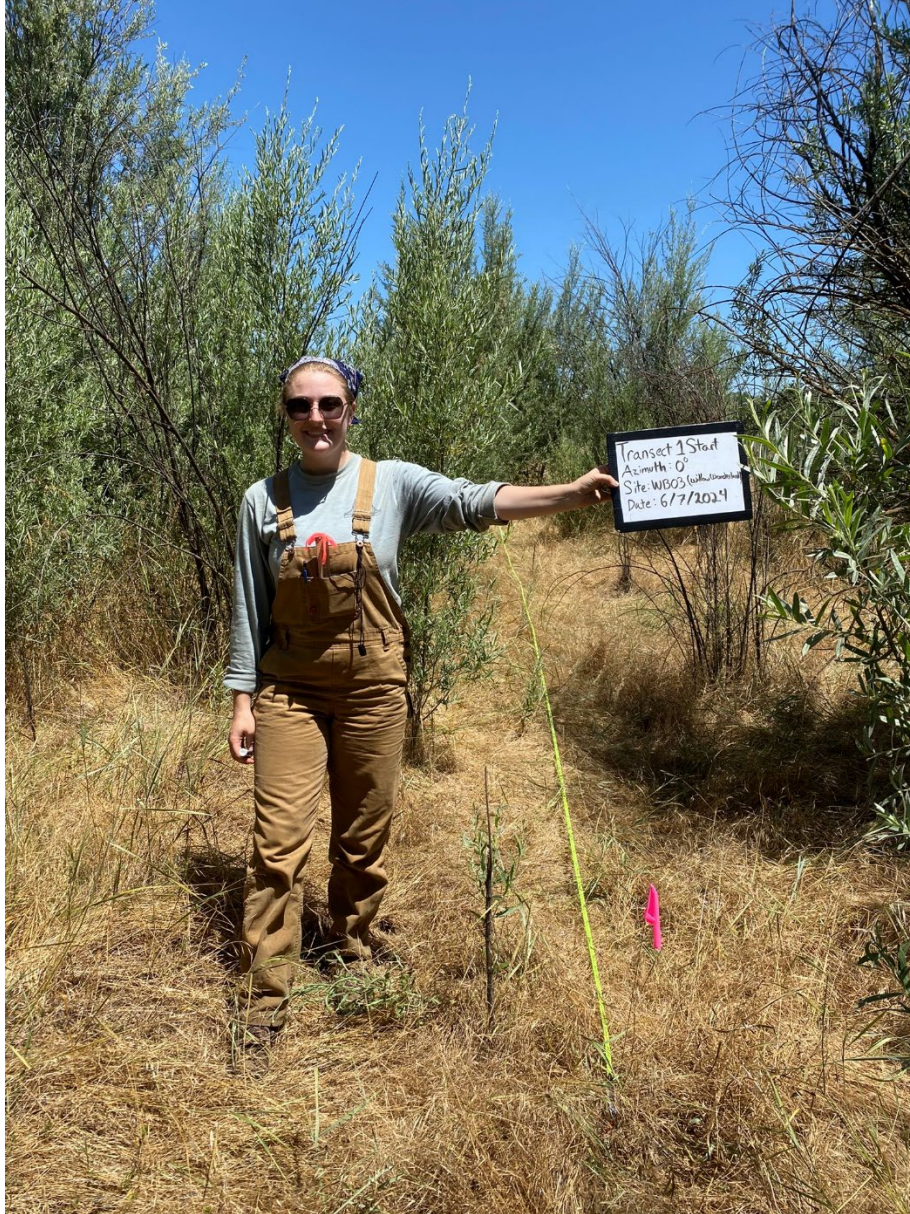
Figure A2.3: Sandbar willow transect at Woodson Bridge Preserve (State Parks), Corning subbasin. Photo taken 6/7/2024

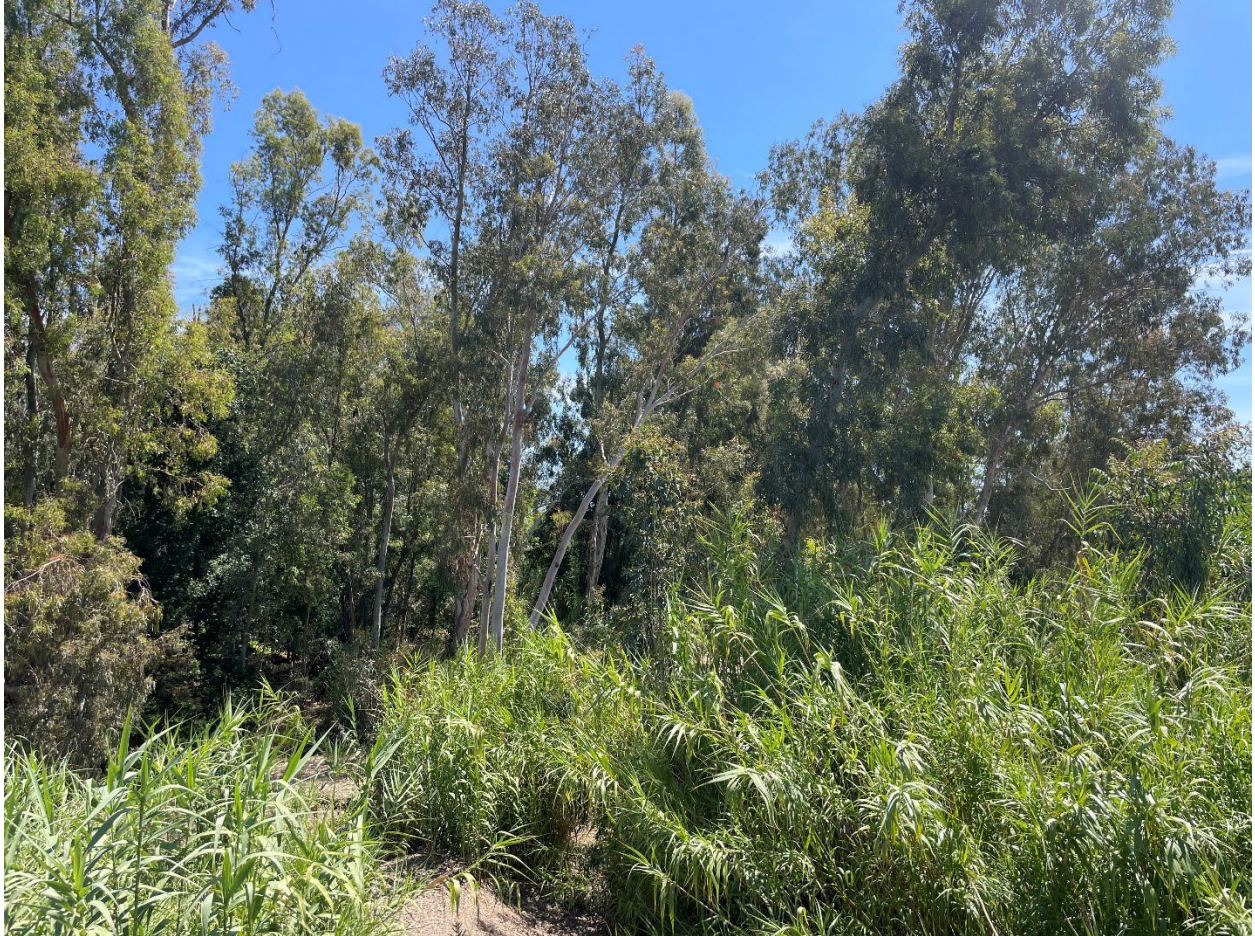
*Figure A4.1: Arundo & Eucalyptus site along Bannin Creek in Corning subbasin. Example of a site removed from iGDE database*

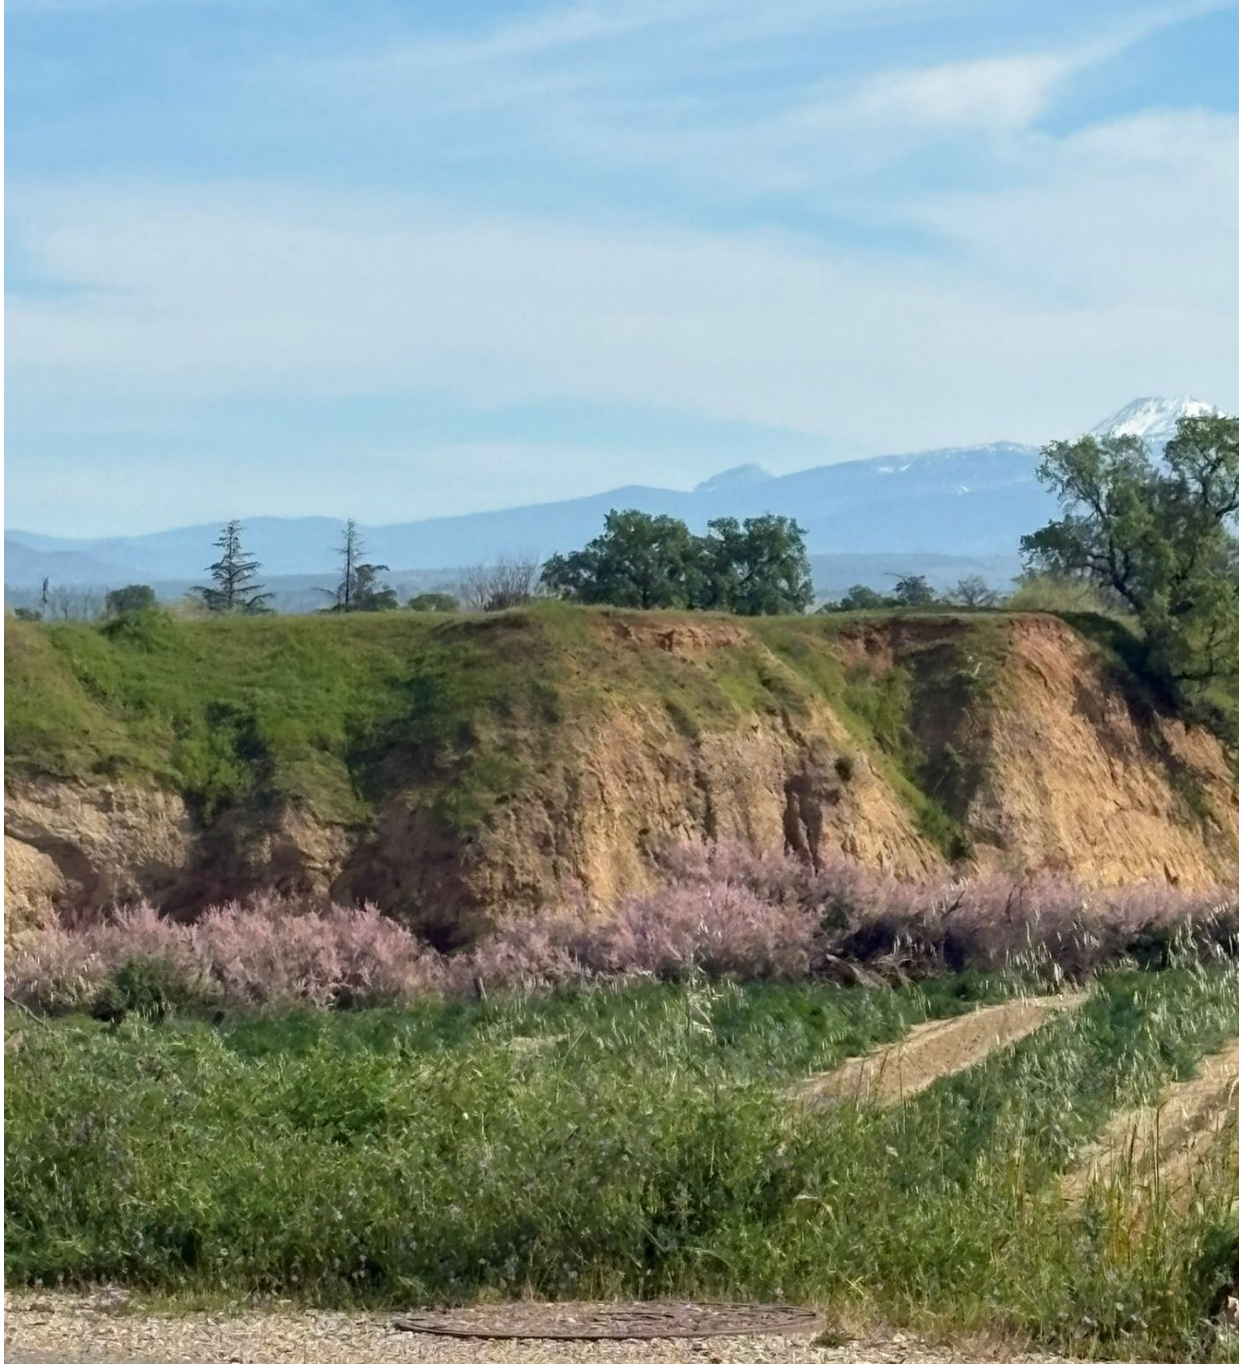
*Figure A4.2: Pink flowering trees are Tamarisk, along Red Bank Creek in Red Bluff subbasin*

Polygons which were dominated by invasive species throughout the Red Bluff subbasin: Tamarisk (103 acres), and 84 acres of Arundo, were removed – and classified as 'not likely GDE' however these sites should be considered for restoration.

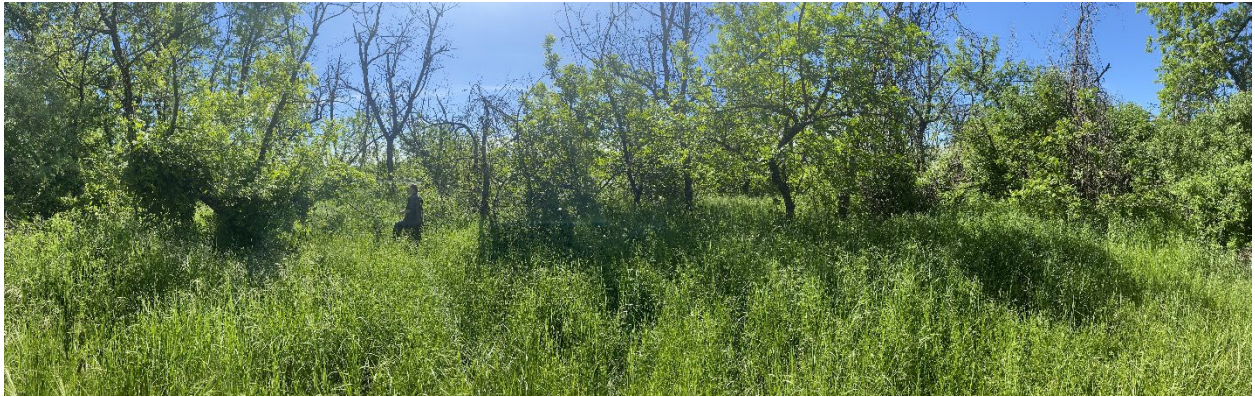
*Figure A7.1: Kopta plot 7, showing healthy, vigorous individuals and some dead overstory of Fremont Cottonwoods (Corning subbasin)*

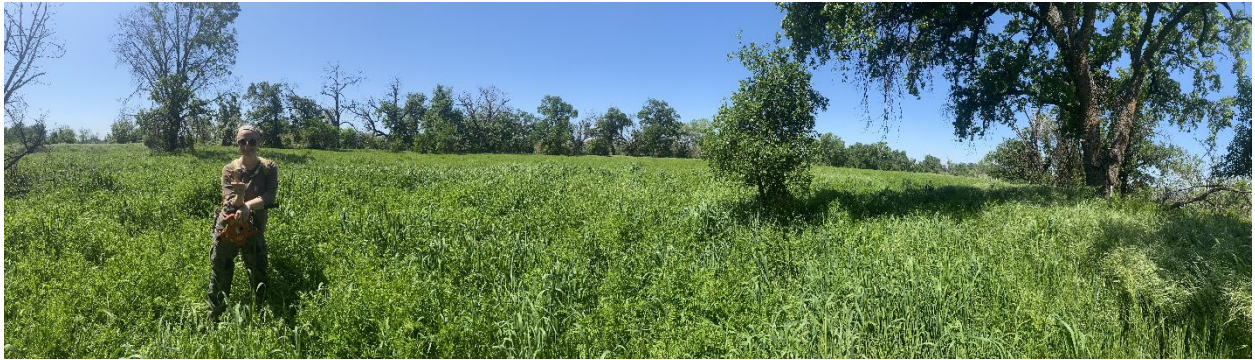
*Figure A7.2: Butler Slough plot 2, showing healthy Valley Oaks in the foreground and some dead overstory in the background (Antelope subbasin)*

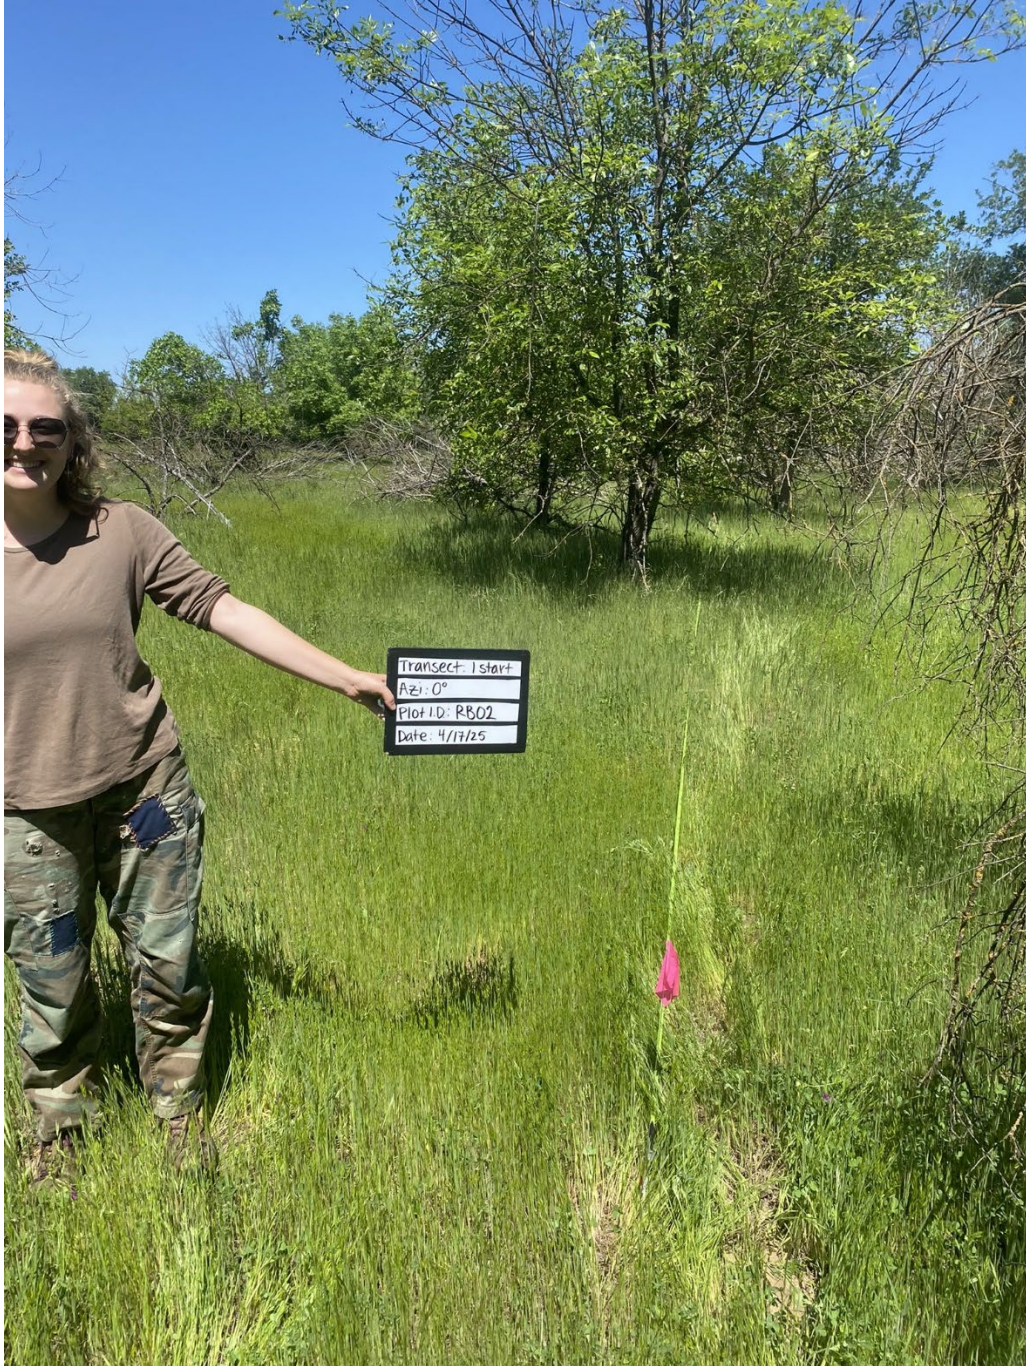
Figure A7.3: Red Bluff Recreation Area, plot 2, showing canopy dieback on Box Elder along transect and dead shrubs in the understory.

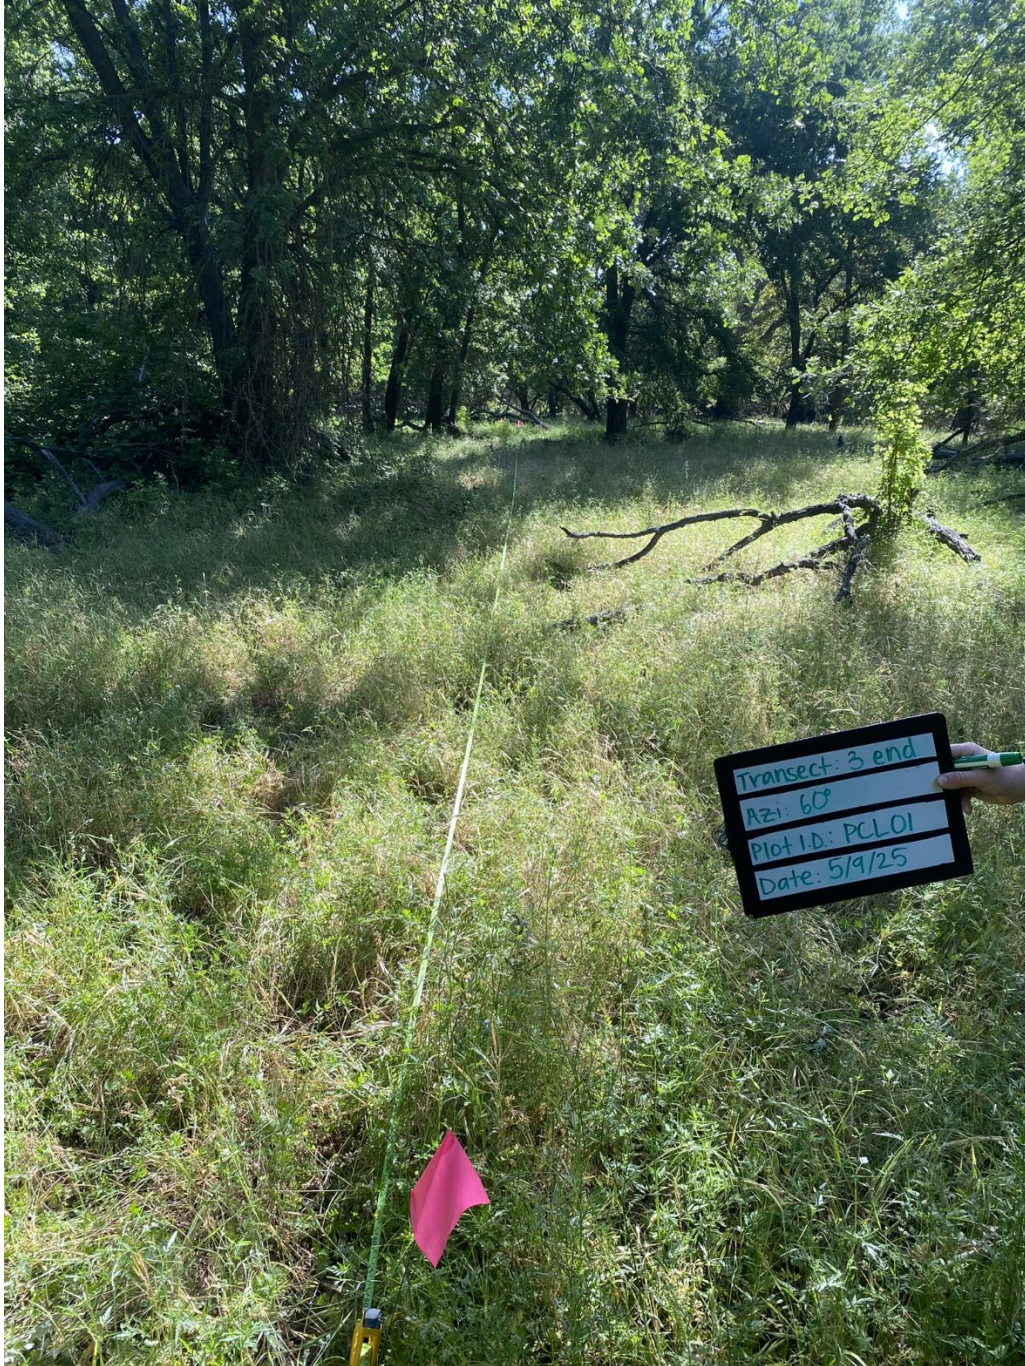
*Figure A7.5: Pine Creek Lower Unit, plot 1, showing healthy, vigorous Valley Oak overstory community*

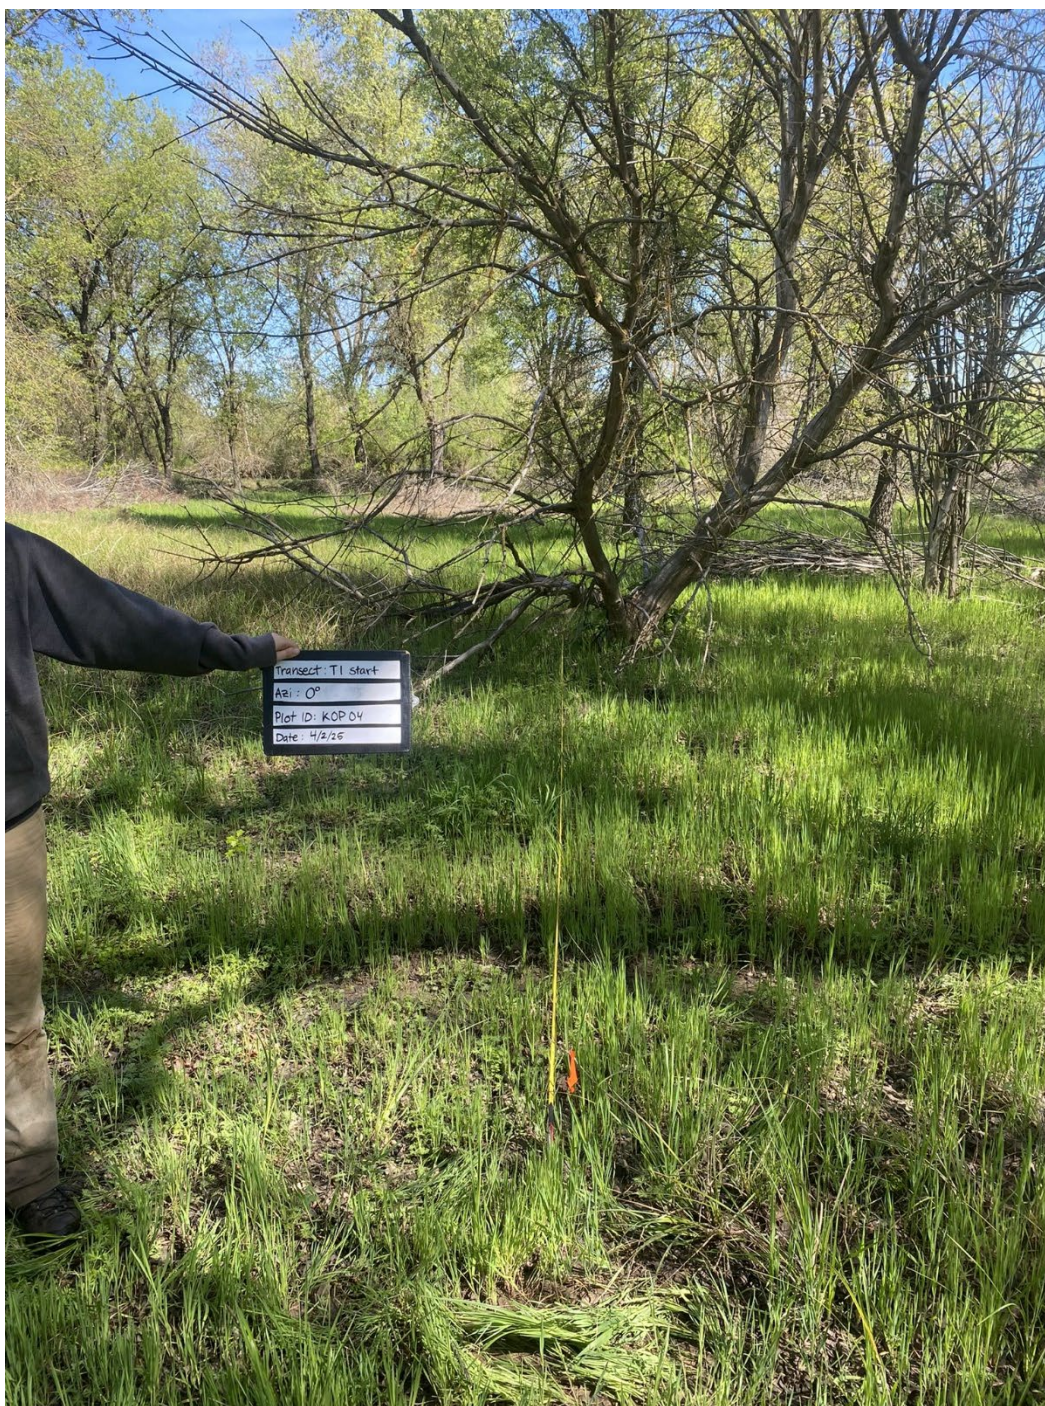
*Figure A7.6: Kopta Slough, plot 4, showing healthy overstory canopy species in background with dead younger Valley Oak individual along the transect.*
